**Docket No. 217 – Development and Management Plan Inspection**

Northeast Utilities Service Company Certificate of Environmental Compatibility and Public Need for the construction of a 345-kV electric transmission line and reconstruction of an existing 115-kV electric transmission line between Connecticut Light and Power Company's Plumtree Substation in Bethel, through the towns of Redding, Weston, and Wilton, and to the Norwalk Substation in Norwalk, Connecticut.

**Date:** January 12, 2006

**Location:** Transition Stations: Hoyts Hill, Archers Lane, Norwalk Junction

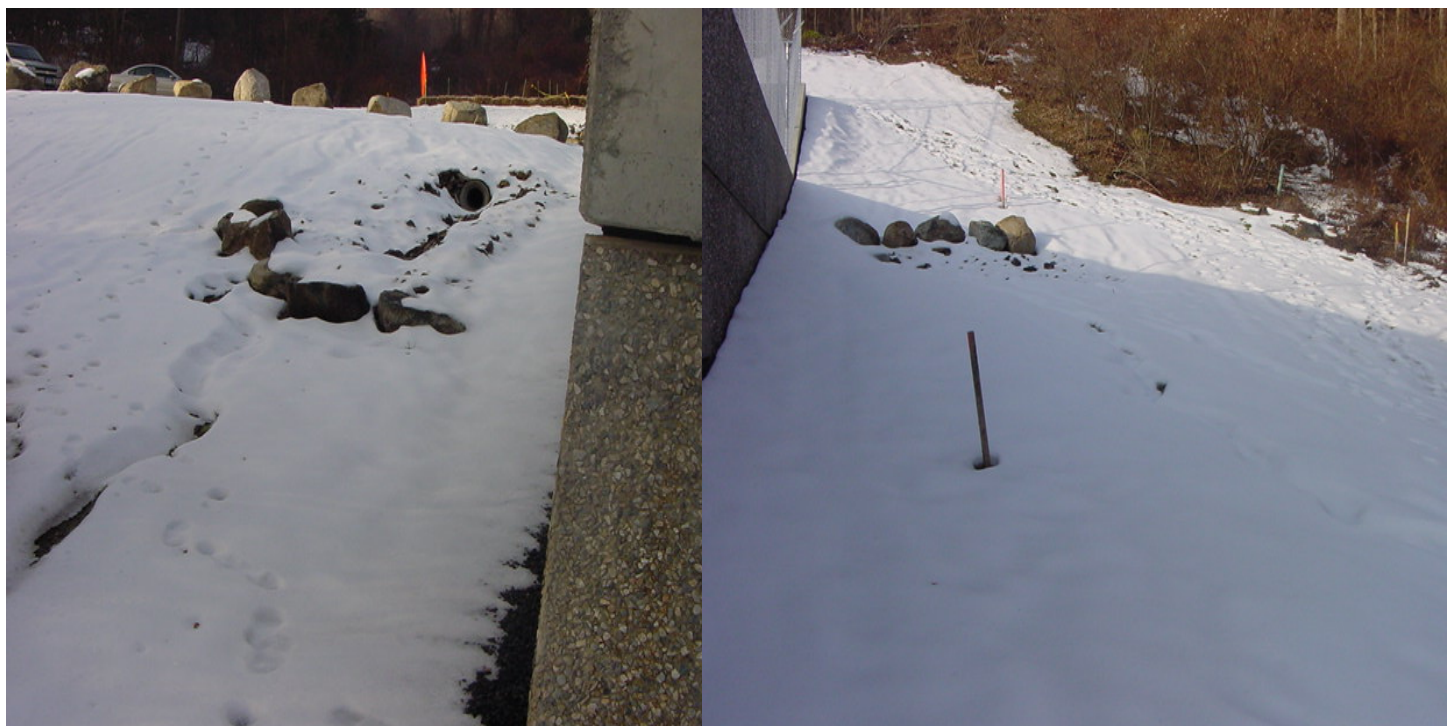
Hoyts Hill Transition Station: Both photos show the erosive gullies still present under the snow cover located on either side of the station yard. 1/12/06

Areas of Inspection	Observation	Recommended Action
Foundation construction continued	<p>necessary on the outlet/dissipater pads as erosive gullies continue. 12/01-1/12/06.</p> <p>-At Archers Lane, construction of the retaining walls continues. 1/12/06</p> <p>- Earthwork and foundation work continues in the station yard and large soil stockpiles were noted. 1/12/06</p> <p>-At Norwalk Junction, 345kV vault work is complete and 115kV structure work is wrapping up. 1/12/06</p>	<p>extended based on the noted erosion issues. See erosion control section. 12/01-1/12/06.</p> <p>-None at this time. 1/12/06</p> <p>-None at this time. The soil remains contained on site. 1/12/06</p> <p>- See erosion control section for more information. 1/12/06.</p>
Erosion and Sediment Controls (includes inspection within 24 hours of a storm event)	<p><b>-Hoyts Hill:</b> The majority of the perimeter silt fence remains in good condition and water was seen running clear through the barrier, although a small amount of sedimentation was noted.1/4-1/12/06</p> <p>- The erosive gullies are still present (under the snow cover) on both the northern and southern slopes resulting in sediment deposits along the silt fence. 10/27-1/12/06.</p> <p>-As stated previously, erosion and sedimentation were noted at the access drive and the haybales did not have much effect. 12/30-1/12/06.</p> <p>- <b>Archers Lane:</b> Monitor stormwater run-off velocity off the engineered slope. This area is steep and water used to collect at the base at the silt fence. It is currently working well. 1/12/06.</p>	<p>- Continue to monitor the area and be proactive in maintenance of the erosion controls, especially in areas with wetland immediately adjacent. 1/4-1/12/06</p> <p>- Gullies should be repaired and a stronger method of stabilization, such as erosion control mats, should be considered. 10/27-1/12/06</p> <p>-Investigate whether extension of the outlet stone pad would help the situation and restore the erosion caused here. 10/27-1/12/06</p> <p>- Ruts should be smoothed out and additional stone installed in the disturbed area of the access drive to prevent further erosion and sedimentation. 12/1-1/12/06.</p> <p>- Continue to monitor this area, especially after significant rain events. Watch the erosion controls during future snow plowing. 1/12/06.</p>

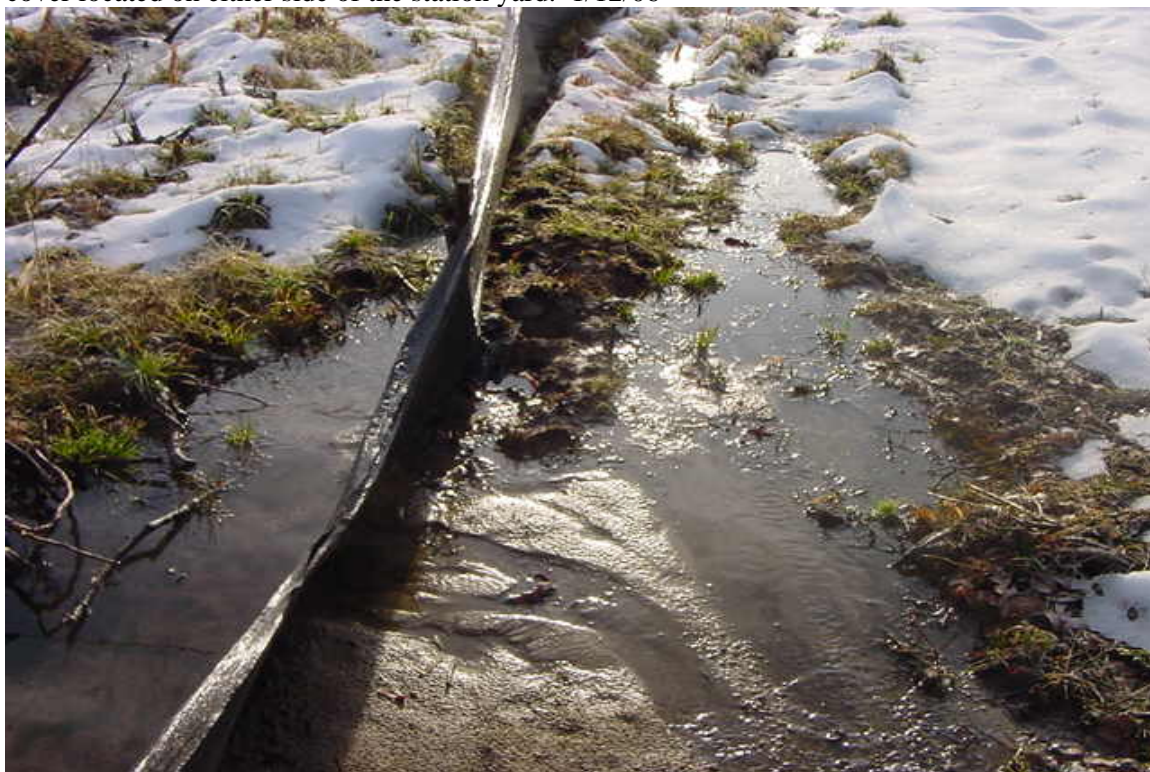
Inland Wetland and Watercourse encroachment and mitigation	<p>- <b>Hoyts Hill:</b> As part of the transition station, a small area of wetland was cleared and altered. The outer silt fence is still up as a work limit. Sediment is accumulating along the fence from the erosion but water continues to run clear through the fence in this area.12/8/05-1/12/06.</p> <p>-<b>Archers Lane:</b> No immediate wetland area concerns were noted. Watch run-off velocity down the completed slopes and walls. 1/12/06</p> <p>- <b>Norwalk Junction:</b> The majority of the perimeter</p>	<p>-Continue to monitor. In general, keep all equipment and materials out of wetlands not to be disturbed and keep controls in good repair. Work is still proposed through here to connect with the underground facilities. 11/10-1/12/06</p> <p>-None at this time. 1/12/06</p> <p>- Perimeter controls still need to be maintained along the river. 12/22-1/12/06</p>

View of the silt fence in place at the wetland boundary. Water flowing through the fence is clear but areas of sedimentation have piled on the work side of the fence due to run-off from the gully. 1/12/06.

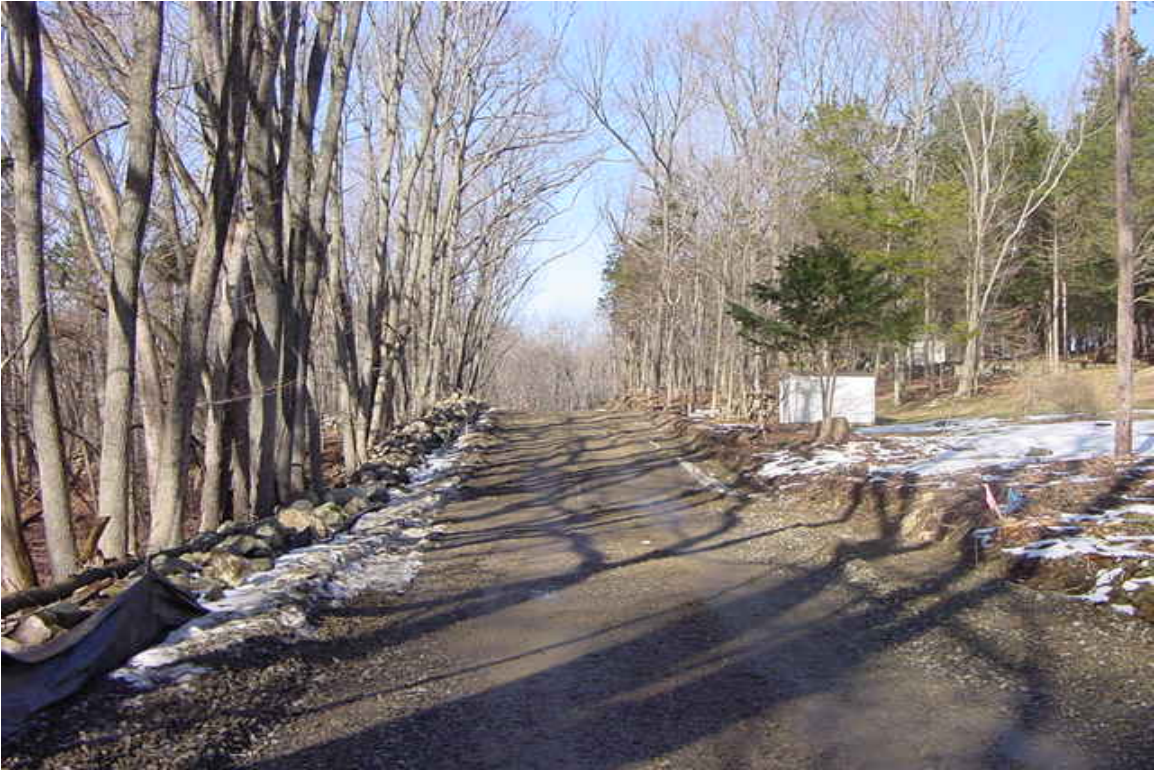
Archers Lane: View looking up the access road from Diamond Hill Rd. 1/12/06.

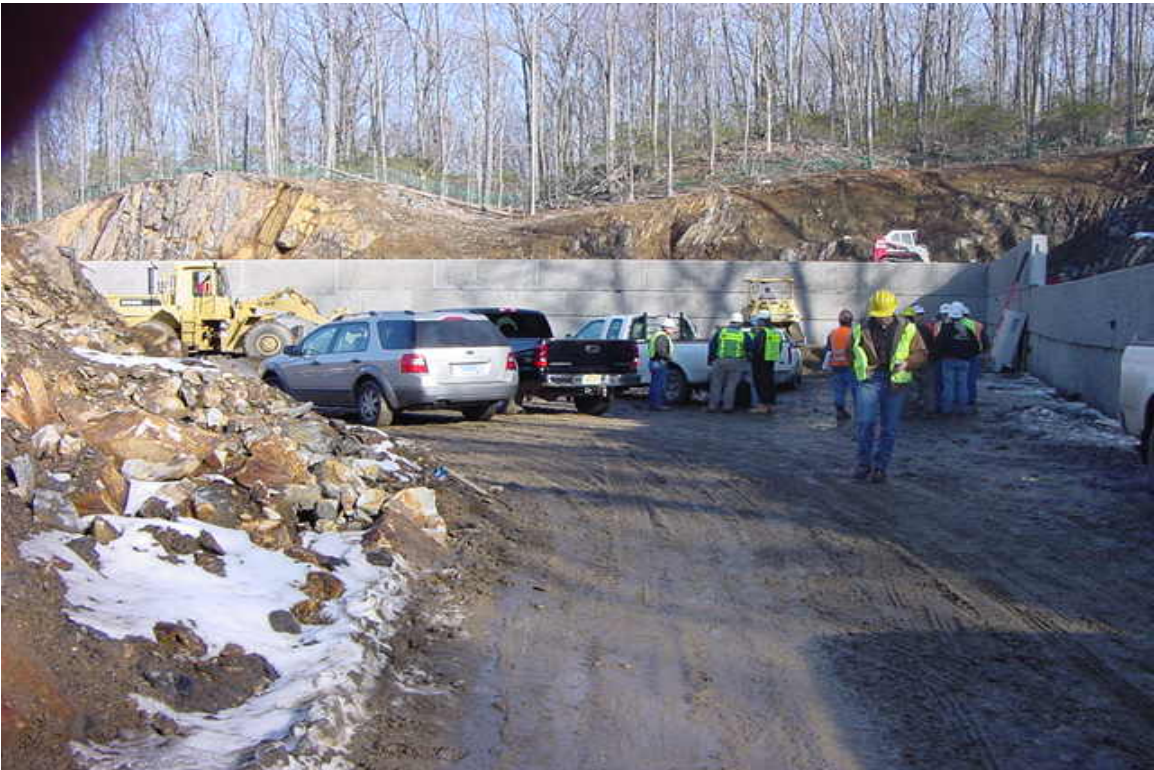
Photo shows the continuing progress being made on the retaining walls. 1/12/06.

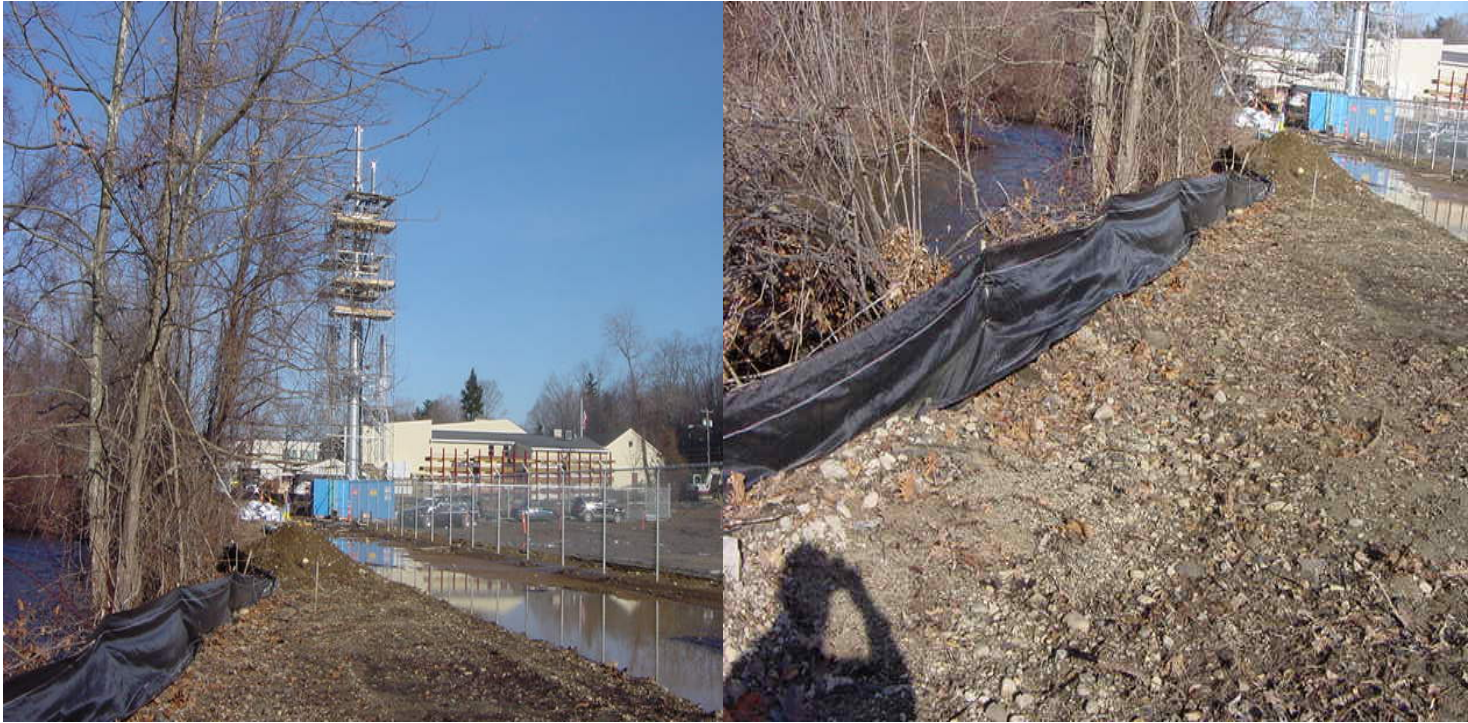
Areas of Inspection	Observation	Recommended Action
Erosion and Sediment Controls continued	<p>- <b>Norwalk Junction:</b> The majority of the perimeter silt fence along the river still needs to be toed-in. 12/22-1/12/06.</p> <p>-The cleared/disturbed area noted outside the silt fence adjacent to the river, remain flooded with pooled water. 12/30-1/12/06</p> <p>- Erosive gullies/soil slumping remain in a number of locations along a portion of the drainage swale due to site run-off, resulting in some sedimentation to the swale. The surrounding soil is disturbed. 12/30-1/12/06.</p> <p>- The front of the site and remaining portion of the swale was very well restored with erosion matting, thick straw mulch and stone check dams. 1/12/06</p> <p>-Dewatering associated with 345kv vault excavation is complete. 1/12/06</p>	<p>- A majority of the erosion control barrier is still in need of attention. 12/22-1/12/06</p> <p>- This area receives direct runoff from the site through the swale making water quality important. 1/12/06</p> <p>- The erosion control matting on the swale likely needs to be extended up and over the top of slope to prevent further erosion until the growing season. 12/30-1/12/06</p> <p>- Similar restoration should continue in other disturbed areas and along the washouts on the lower swale. 1/12/06</p> <p>-Any future dewatering needs on site will require significant efforts to control turbidity to this swale. 12/14-1/4/06</p>

Norwalk Junction: Photo on the left shows an overview of the site. 115kV contractors will be removing scaffolding from the structure. Photo on the right shows the silt fence along the perimeter of the site which still needs to be toed-in. 1/12/06

Areas of Inspection	Observation	Recommended Action
	<p>erosion controls along the Norwalk River need to be toed-in. 1/12/06</p> <p>- Flooding may be an issue during extended periods of rain. 11/23/05- 1/12/06</p> <p>- The outlet of the drainage swale is at the headwall of the wetland area. Turbidity issues have been noted here in the wetlands but have not had a significant impact on the river. 12/30-1/12/06.</p>	<p>-Since silt fence has been washed over before, consider reinforcing with wire fence as well. 1/12/06</p> <p>-See Erosion Control Section for more details. 12/30-1/12/06</p>
State species of concern, threatened and endangered species	- No species of concern are located in these areas of construction.	- N/A
Vegetative clearing limits (including trees to save or danger trees noted)	<p><b>-Hoyts Hill:</b> The slopes and areas surrounding the site had begun to experience noticeable increase in growth before the cold weather but erosion issues continue and will need attention. 11/17-1/12/06</p> <p><b>- Archers Lane:</b> No new clearing was noted during this inspection. 1/12/06</p> <p><b>- Norwalk Junction:</b> The area that had been cleared outside the silt fence (11/23) now has pooled water. 12/30-1/12/06</p>	<p>- It will be difficult to obtain sufficient growth due to the late time of year. An alternative method of stabilization, such as Erosion Control Mats should be considered. 11/02-1/12/06</p> <p>-None at this time. 1/12/06</p> <p>- This area was not restored or enclosed in silt fence but is now partially flooded. 1/12/06</p>

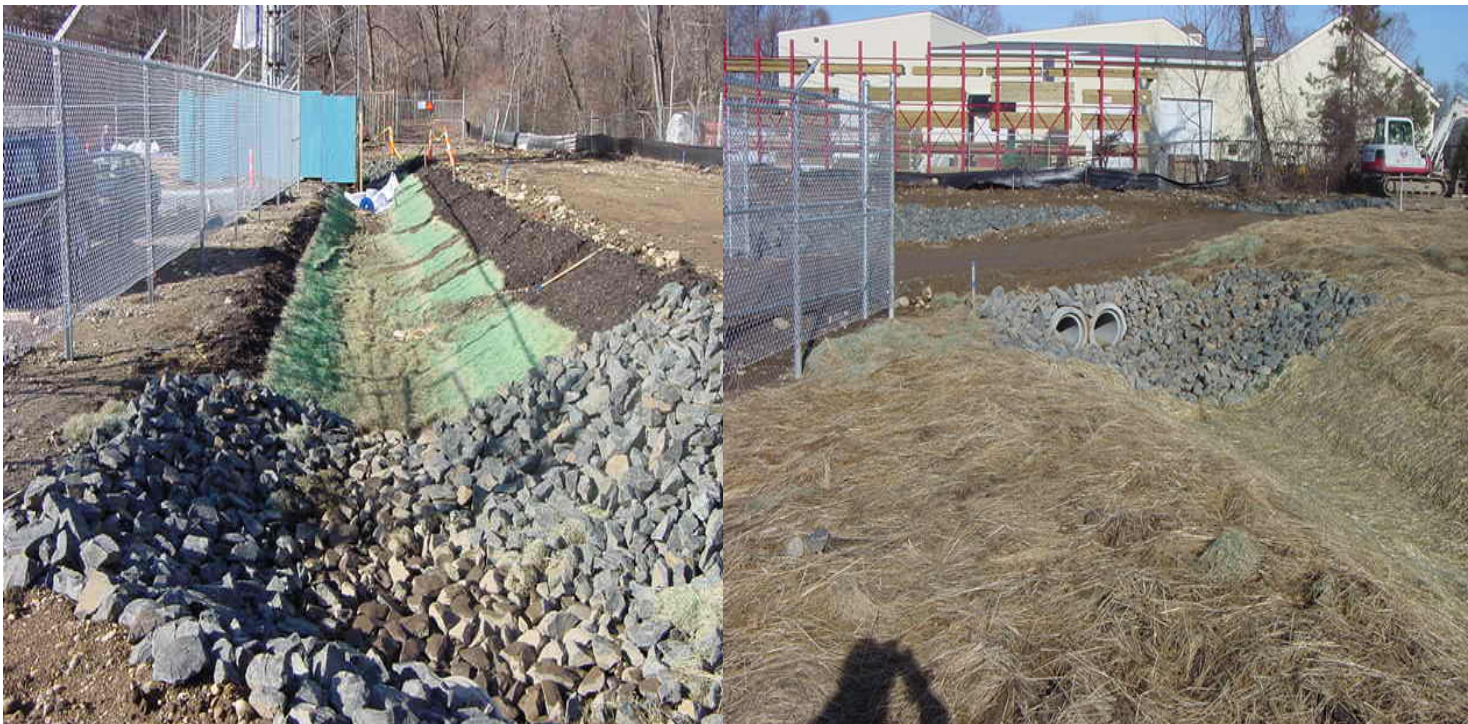
Photo on the left shows a portion of the swale where erosive gullies and washouts were still present. Photo on the right shows very good restoration of the remainder of the swale and adjacent area. The swale here was placed with erosion matting/netting and mulched heavily with hay. Stone check dams are also in place. Continue to restore in this manner where feasible and repair the washouts. 1/12/06
